Report of an  
Unidentified Aerial Phenomenon and its Safety Implications  
at O'Hare International Airport on November 7, 2006  
Case 18

Richard F. Haines, Ph.D. Senior Editor  
Chief Scientist

March 9, 2007

National Aviation Reporting Center on Anomalous Phenomena<sup>1</sup>

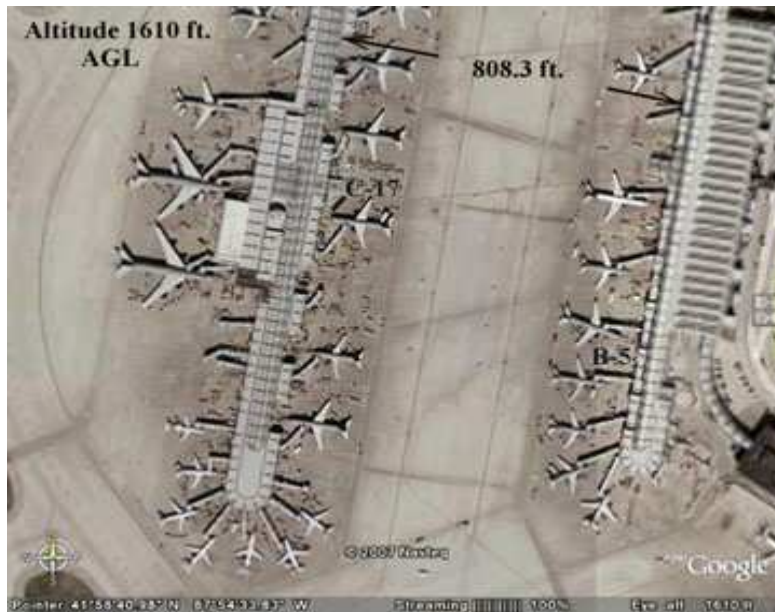
Figure 1. Aerial Photograph of United Concourses B and C from Altitude of 1,610 Feet.

The following narrative presents an approximate chronological reconstruction of what took place during this incident showing where each eye witness<sup>3</sup> was at the time (Table 1). Numbered events and letter-identified witnesses are marked on an aerial photograph of the airport property taken from an altitude of 1,800 feet (Figure 1).<sup>4</sup> Letters represent the approximate location of each witness. As will be discussed, whether or not the UAP could be seen depended upon the vantage point of each witness.

<sup>16</sup> It must be assumed that what was meant was an oval which is what one would see when looking at a horizontally oriented circle (e.g., coin) from an oblique angle of about nineteen degrees from below. The distance between the witnesses near the maintenance hanger and gate C17 (cf. line in Figure 4) was about 5,500 feet. Also cf. similar testimony by witness J.H. in Appendix E.1 [9].

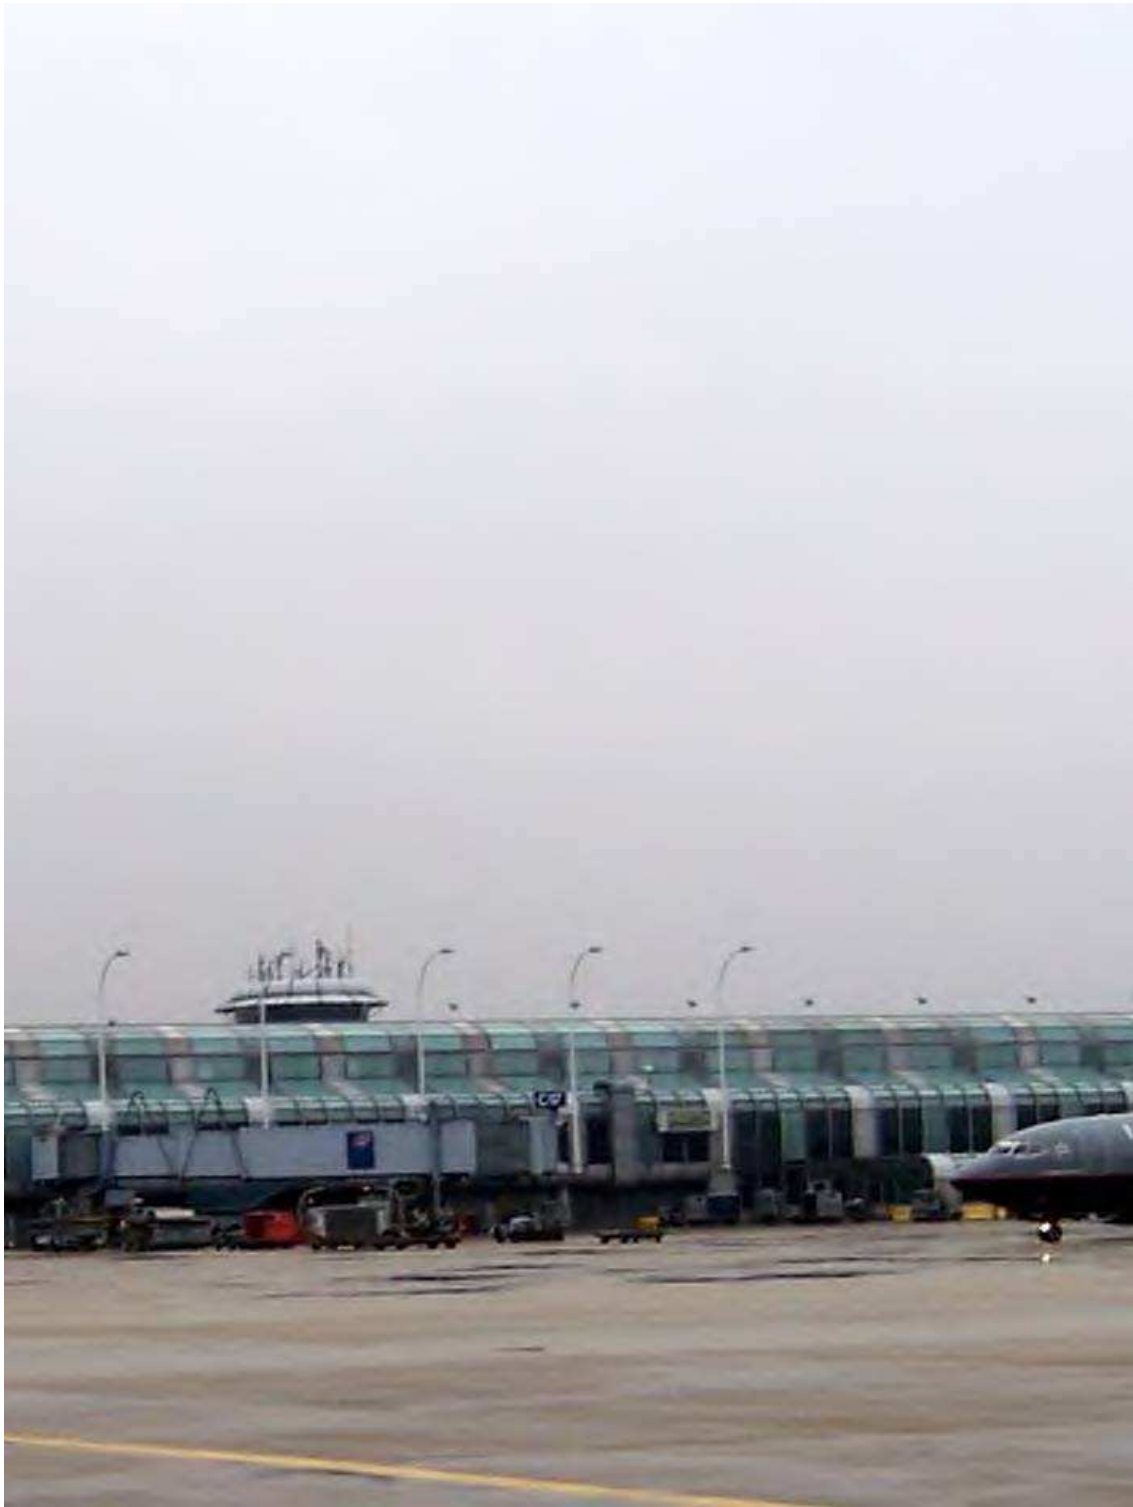
Figure 2. View of United Concourse C with Gate C17 Visible at Center  
(United Ramp Control Tower Seen on Roof at Left-Center)

Witness A. The earliest known witness was Mr. X.X. (witness A) who was assisting the push-back of a B-737-500 from gate C17. He was standing on the tarmac beside the nose of the jet with his communication headset cable plugged into a connection port in the nose of the airplane. Figure 2 is a photograph taken at gate B5 looking toward gate C17. At about 4:30 pm witness A said that, "...he was compelled to look straight up for some reason and was startled to see the craft hovering silently." He then made a radio call over his head-set to the airline's operation center to Sylvania, United Airlines Zone 5 control coordinator who is responsible for ten gates. He then told the cockpit crew in the airplane beside him about what he was looking at. One or both of the crew allegedly opened their side windows and looked up at the UAP<sup>5</sup>, however, this cannot be confirmed. Later, witness A said that he thought the object was between 500 and 1,000 feet altitude directly above his gate. He was sure that the UAP was round and rotating "pretty fast." He said that the object "shot off into the clouds about two (2) minutes after his initial sighting... (and) that it was about the same angular size as a quarter held at arm's length (26") (just over two (2) deg. arc) diameter." He estimated that between ten and fifteen people had seen the object.

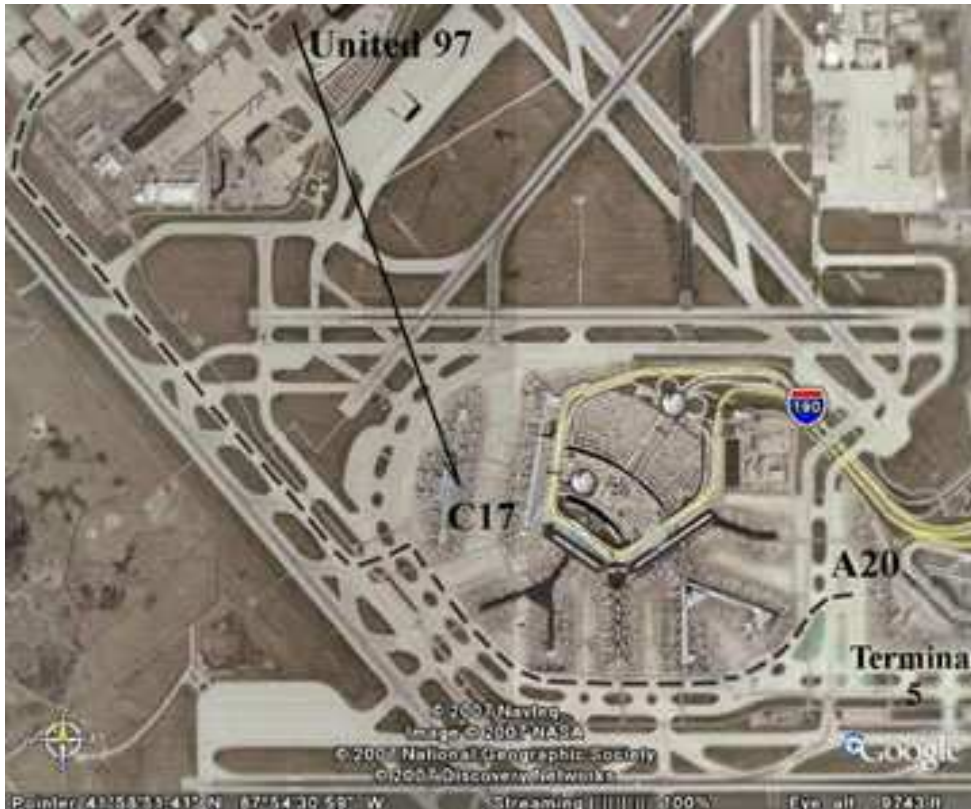
Figure 4. Aerial Photograph of Taxi Path of B-777

The dashed line in Figure 4 shows the taxi path of the empty jet taxied by witness B and C from A20 to the United maintenance hanger (labeled United 97)

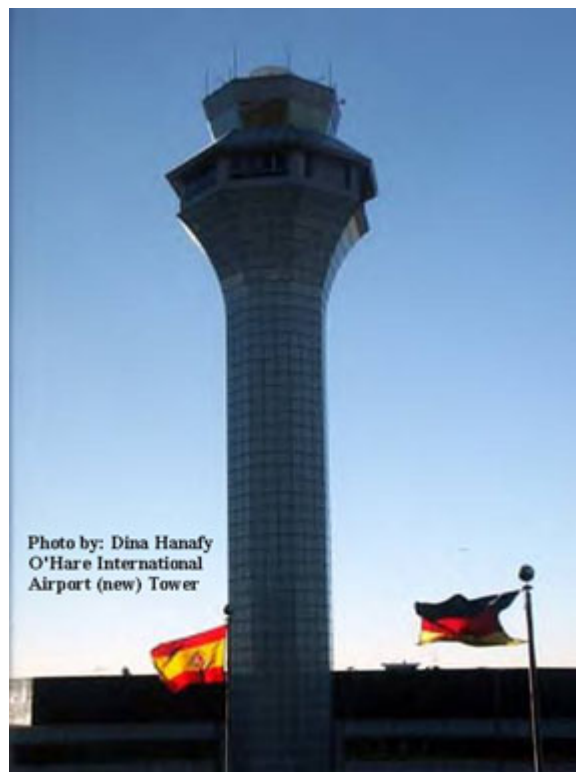
Figure 7. New O'Hare Airport Control Tower

The new control tower at O'Hare International Airport, completed in 1995, is 253 feet tall (905 feet MSL). It is shown in Figure 7. The ATC work area is at the level of the transparent outward sloping windows.

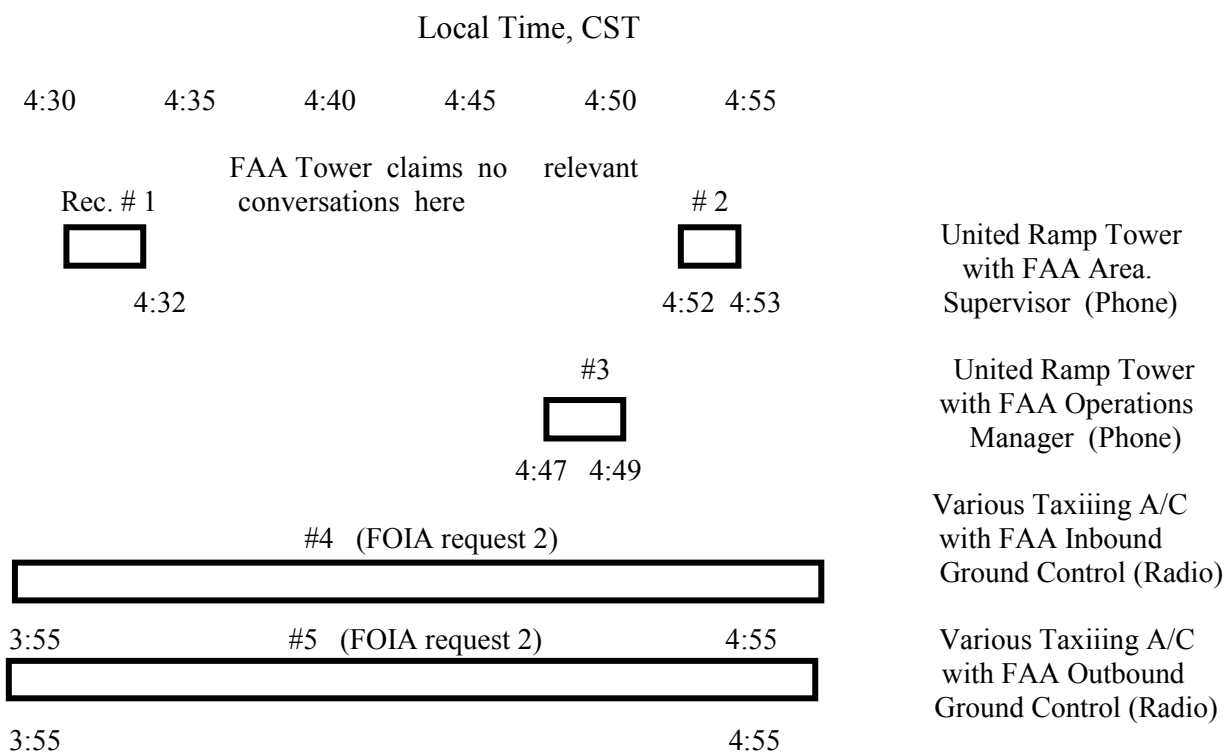
Figure 10. Diagram of Control Tower Voice Recordings Received Through NARCAP's F.O.I.A. Requests

It should be noted that for the thirty minute period from 4:30 to 5:00 pm three different communication channels were used (cf. right side of Figure 10). Data segments that were received extended from 4:30 to 4:32 pm (box #1), from 4:47 to 4:49 pm (box #3), from 4:52 to 4:53 pm (Box #2). All of these voice tape recordings were certified as being accurate.<sup>44</sup>

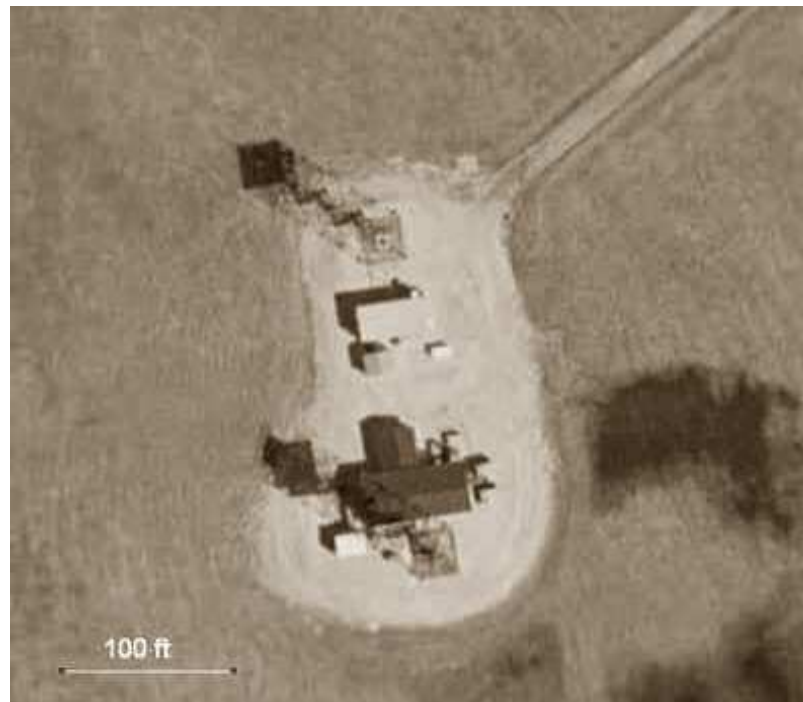
Fig. 15 Aerial View of ASR-9, ORD #1, Chicago O'Hare, Dupage County, Ill.

The main FAA surveillance radar serving Chicago O'Hare is designated in the FAA NAS Architecture (ref.12) as CHICAGO SRR (ORD) and is located in Dupage County, Illinois. Most of O'Hare Airport is located in Cook County. However satellite photos (Fig. 15) show what appears to be an ASR-9 radar antenna tower on the west side of the airfield, 600m over the county border inside Dupage County, consistent with the statement of a case witness and with the FAA supplied information.

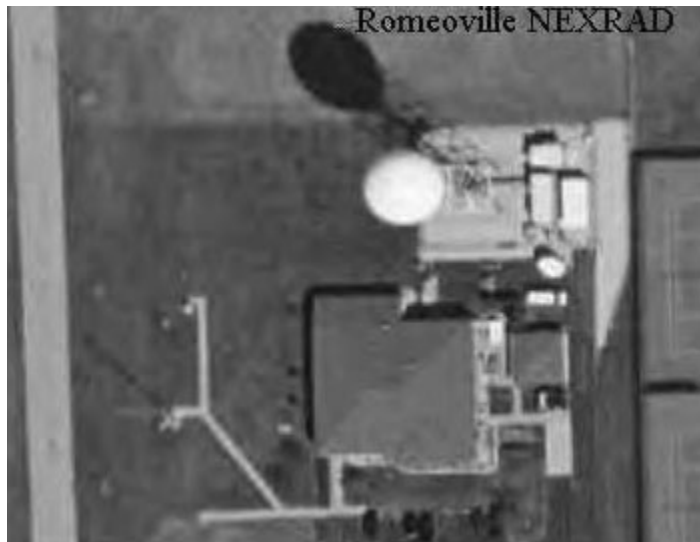
Figure 19. Aerial View of NEXRAD WSR-88D Weather Radar at Romeoville, Ill.

The nearest NEXRAD WSR-88D radar is at Romeoville, Illinois (Fig. 19).

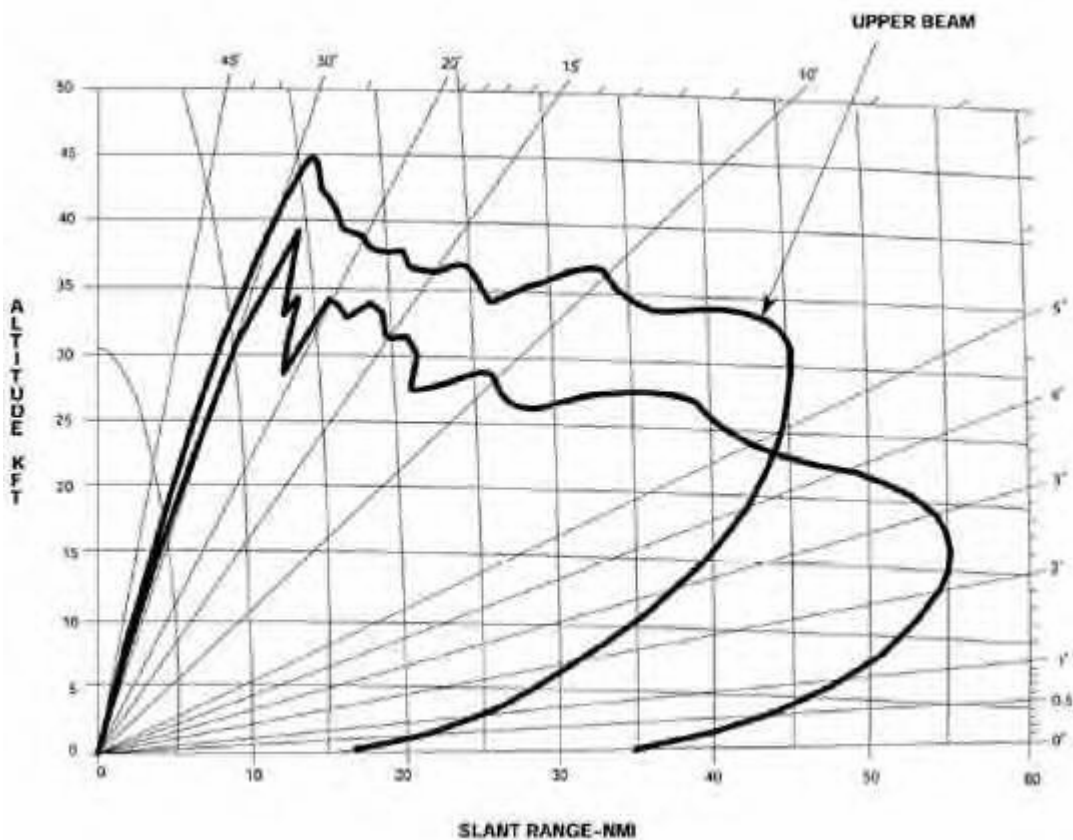
Figure 21. ASR-9 Radiation Pattern VPD Showing Contours of Equiprobability of Detection for a  $1\text{m}^2$  Target in High and Low Beams (from ref. 3)

The ASR-9 coverage pattern was then investigated in more detail. A vertical polar diagram of an ASR-9 radiation pattern is shown in Fig. 21. Range performance is measured in terms of probability of detection ( $P_d$ ) of a target of a given cross-section, and maximum usable range is defined by a  $P_d = 0.8$  or greater. The two curves in Fig. 21 represent contours of equiprobability of detection for a target of  $1\text{m}^2$  in each of the two beams. The ASR-9 low beam is optimised for low elevation targets (peak sensitivity at  $\sim 2.5$  degs) at longer ranges generally beyond 15 - 20 nmi out to the maximum range of 60 nmi; the high beam (peak sensitivity at  $\sim 7$  degs) is optimised for subclutter visibility of shorter range targets at higher elevations.

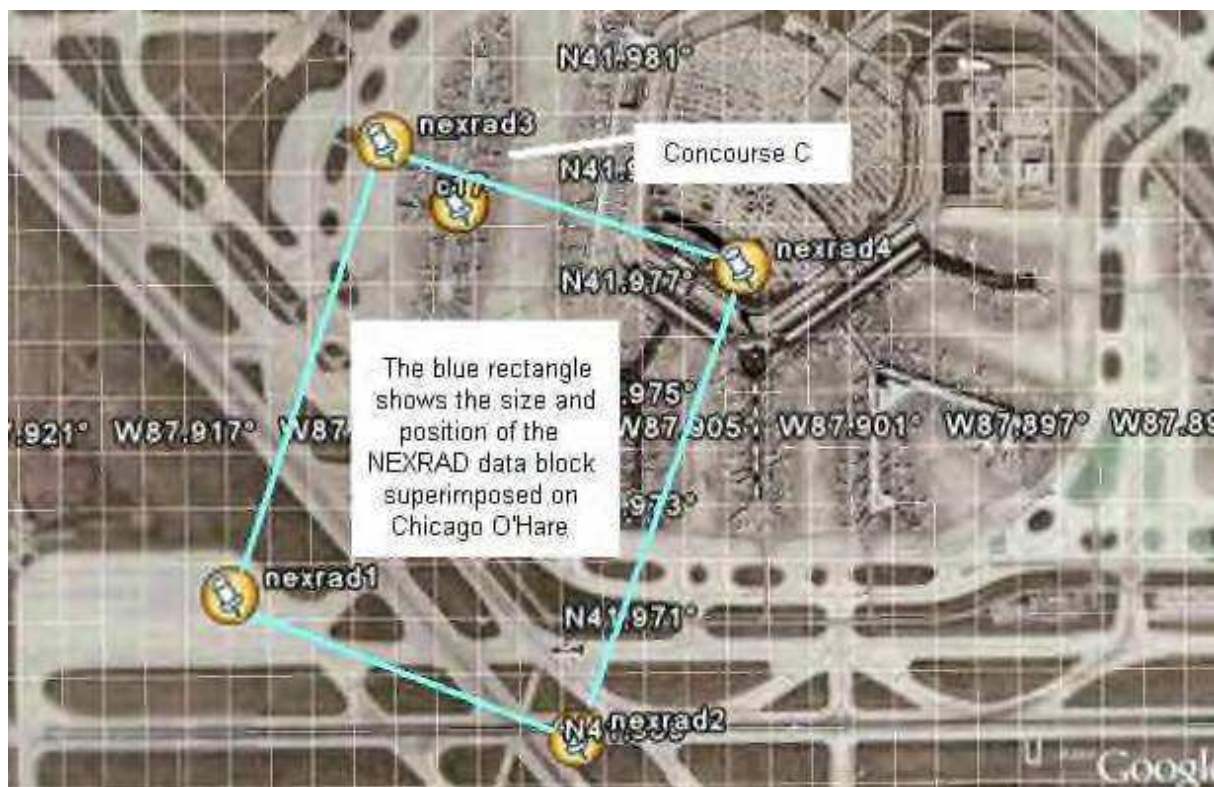
Figure 25. Footprint of the NEXRAD Radar Resolution Cell Superimposed on the Sighting Location (adapted from image supplied by James Smith)

The images show that Romeoville WSR-88D did detect some echo, at the average signal reflectivity level less than light precipitation, in the resolution cell corresponding to the sighting location above Gate C17 and at an altitude not inconsistent with the visual reports, at 1616 CST, and again at 1635 CST. The latter is within a few minutes of the estimated sighting time. However, the ground foot print of the resolution cell is rather large (Figure 25) and there are several possible interpretations for the echo, making this a result of limited value (see Section 6).

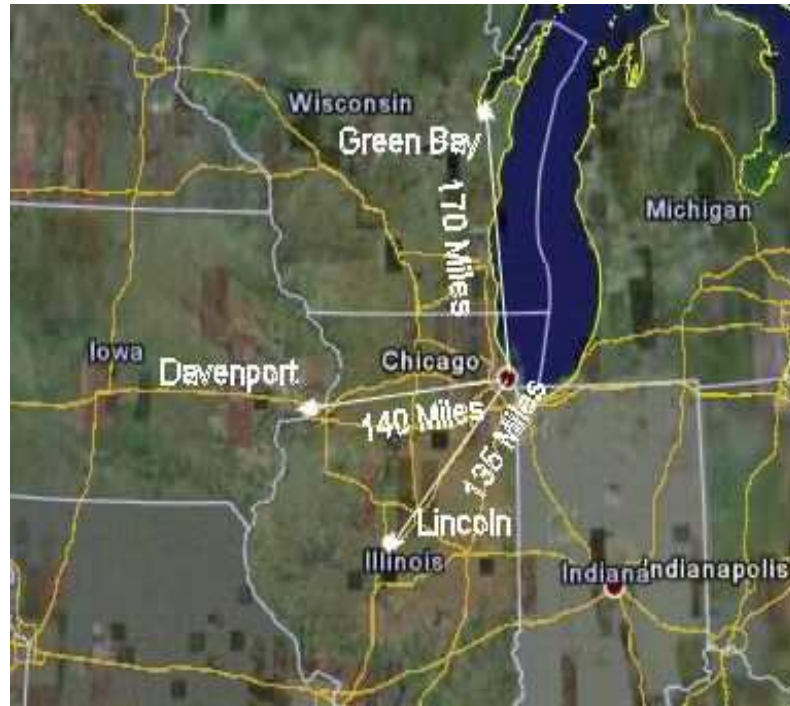
Figure 33. Map Showing Three Upper Air “Balloon Sites” Nearest O'Hare  
(The Most Representative Upper Air Site is Davenport, Iowa – 140 Miles Away)

Figure 33 shows the location of O'Hare Airport and the three closest upper air stations. Davenport, Iowa was chosen as the most representative site for O'Hare Airport at the time of the sighting because of its proximity and wind conditions at the time.

The first problem with this hypothesis is where a weather balloon would come from in the first place. As Figure 33 shows, the nearest launch site for weather balloons is at Lincoln, Illinois, some 135 miles to the SW. With winds out of the south at only about four knots, both of the daily balloon launched from there (one at 6:00 am and the other at 6:00 pm CST) would have climbed above 1,900 feet after only about four minutes flight (assuming a nominal ascent rate of 500 ft/min)! According to the National Oceanographic and Atmospheric Administration (NOAA)<sup>80</sup> who launch about seventy weather balloons a day within conterminous America,<sup>81</sup> the standard tan latex (or synthetic rubber neoprene) balloon is about six foot diameter when launched but increases in size to about twenty feet at its nominal bursting altitude of at least 90,000 feet. At high altitudes they assume a teardrop form due

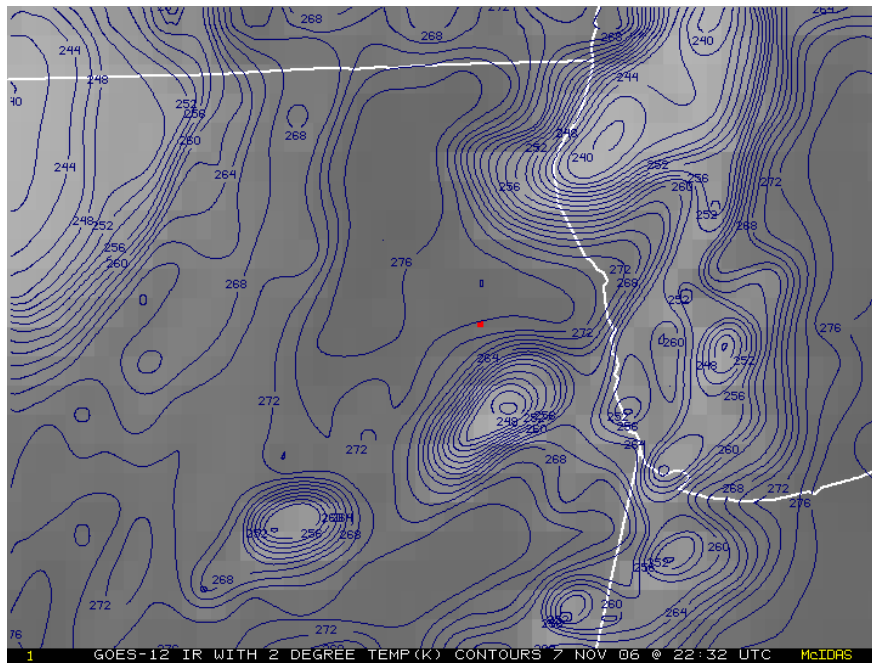
Figure 35. GOES-12 Satellite Cloud Top Temperature Profile for November 7, 2006 over the Greater Chicago Region

The sounding data (Figure 11) and lapse rate data (Table 7) show that two layers of clouds were likely in the lower 10,000 feet as discussed in Section A.2 above. These cloud top computations are supported by the satellite cloud top temperature data shown in Figure 35.

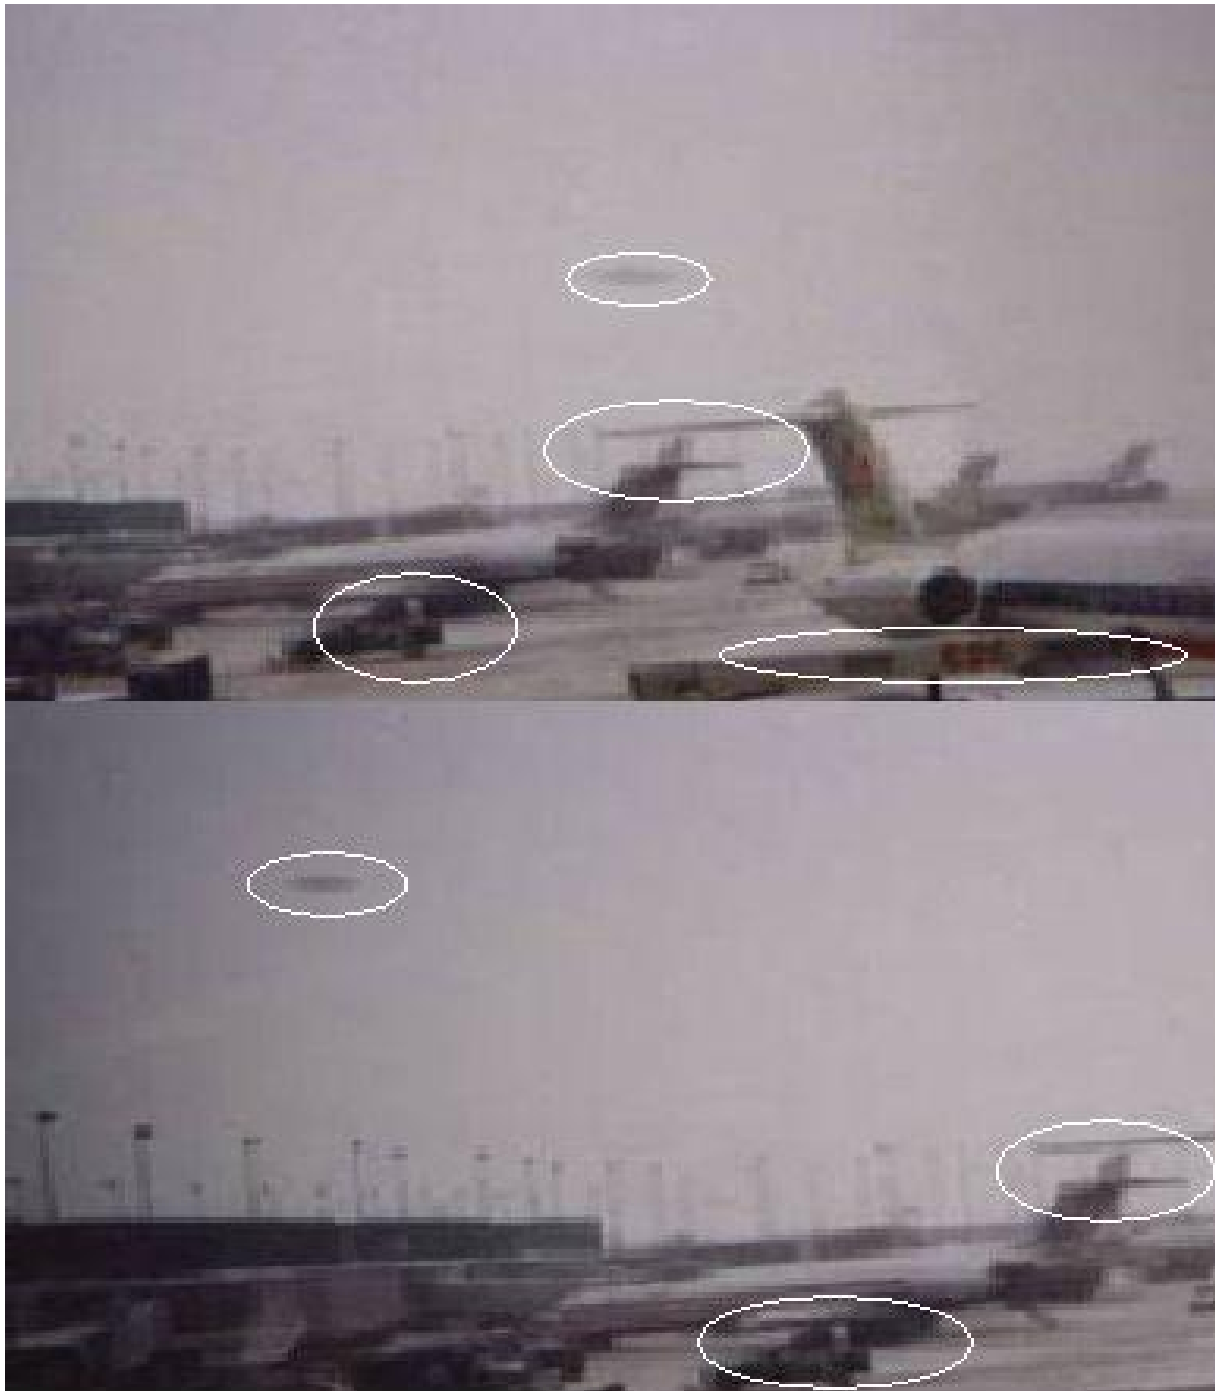
Figure 37. Hoaxed Photo at O'Hare

Figure 37 is an example of a hoaxed photograph of the November 7, 2006 O'Hare incident that was submitted anonymously via the internet by an individual who learned of the case prior to the completion of NARCAP's investigation. When this photo was shown to one of the primary witnesses he said that the aircraft pictured were MD-80s that United no longer flies, that the disc seen in the sky is "much too big, is in the wrong place, and is hazy."<sup>86</sup>

Many of these hoaxes have been revealed by sharp-eyed internet surfers who can find source photos on the internet and compare them with alleged incident photos. The picture above is actually a hoax that was resolved by comparing a photograph of O'Hare terminals found through an internet search with that of the alleged photo of the incident. It is clear that the original image had been acquired from an internet website. The photograph was simply “reversed” and a UAP inserted, all done with the help of common computer imaging software.

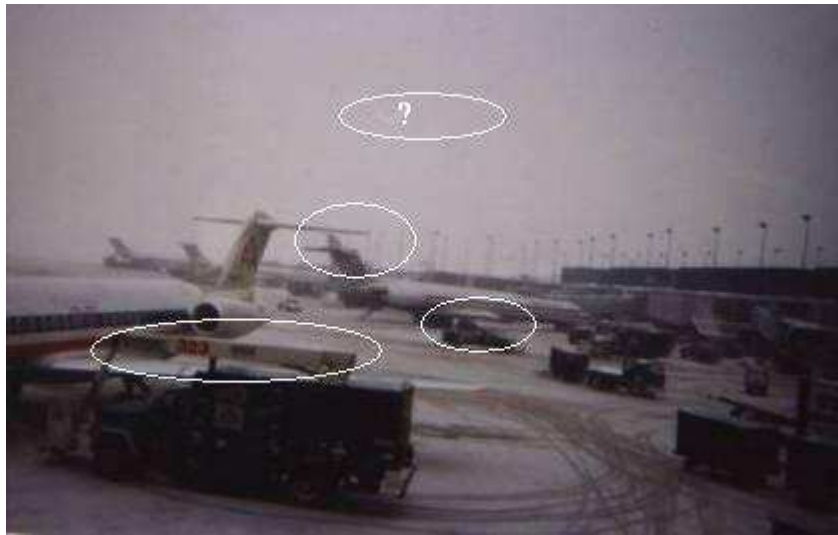
Figure 38. Original Photograph that was modified to create the Photographs in Fig. 37

Figure 38 shows the original source image.<sup>87</sup>

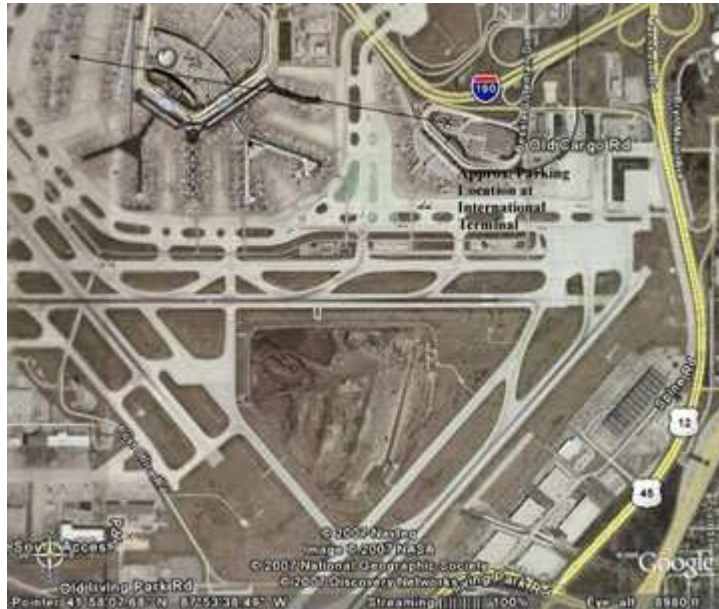
Figure 39. Aerial Photograph of O'Hare Airport Related to Witness Testimony Provided by Ms. J. H. narcap#18\_MsJHroadpath1.jpg

The witness was turning off Mannheim Road into O'Hare to terminal five when she first noticed the object in the sky. Figure 39 shows an aerial view of the area involved. Mannheim Road is the yellow road on the right side running to the north.

<sup>98</sup> Elsewhere she states that she watched the object for approximately ten minutes at this location (cf. E.1, and #8). This particular intersection is visible on Figure 39 in the lower right corner where the two yellow roads intersect.
